## Special Commission on the 1999 Texas A&M Bonfire

# **Final Report**

May 2, 2000

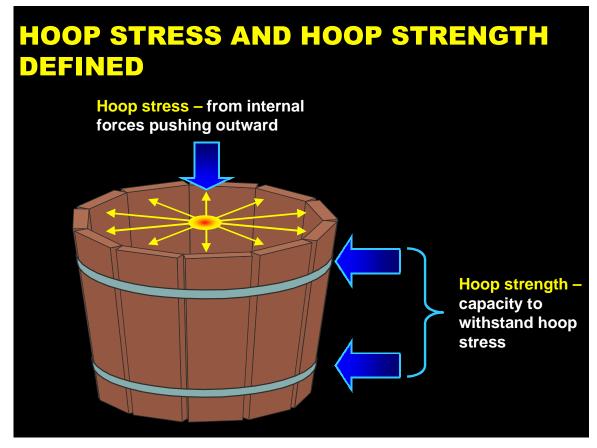
These terms are more clearly defined as follows: hoop stress results from outward pressure in a cylindrical structure, like a barrel, that is due to internal lateral forces. Design, shape, or even gravity can drive these forces. Hoop strength is the ability of a cylindrical structure to contain hoop stress. Hoop strength is normally provided by some containing mechanism – in the case of a barrel, it is provided by the metal bands wrapped around the wooden slats. The metal bands must sustain the hoop stress in order to keep the barrel together.

Containment strength is typically called "hoop strength." The actual failure resulted from excessive "hoop stress" that overcame the Bonfire's hoop strength.

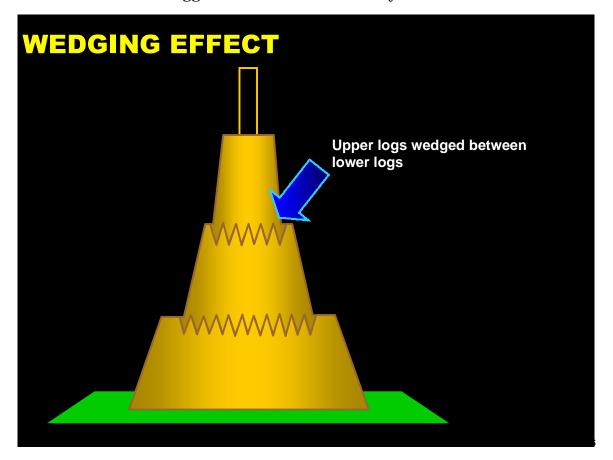
Additionally, interviews with student leaders showed that while wedging was used only moderately or not at all in previous years, it was used very aggressively in 1999.

Please note that the factors illustrated in the following four drawings have been exaggerated for the sake of clarity.

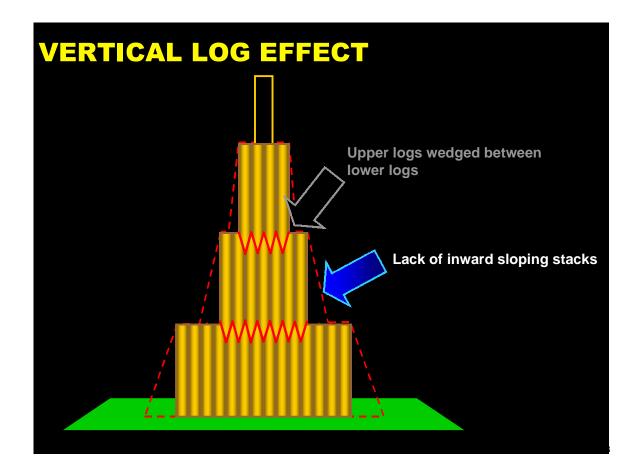
2. Vertical log orientation – as was evident from the previous photographs, early Bonfires had a teepee-shaped design. Logs in later Bonfires, especially 1998 and 1999, were stacked much more vertically. Vertical logs by themselves might not have caused the collapse, but they did increase the forces acting on the wires.

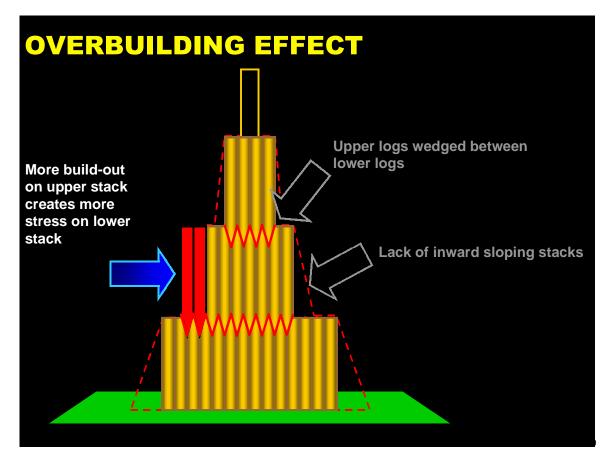
3. **Overbuilding** – results when an upper stack is built-out too closely to the edge of a lower stack. The result is increased localized hoop stresses on the lower stack. Hoop stress is less when the lower stack is built out much wider than the upper stack. According to interviews, the overbuilding of the 1999 stack was toward the southeast, with a distance of just one foot or so from the second stack to the edge of the first stack. This overbuilding amplified the wedging effect to the southeast, contributing to the failure.

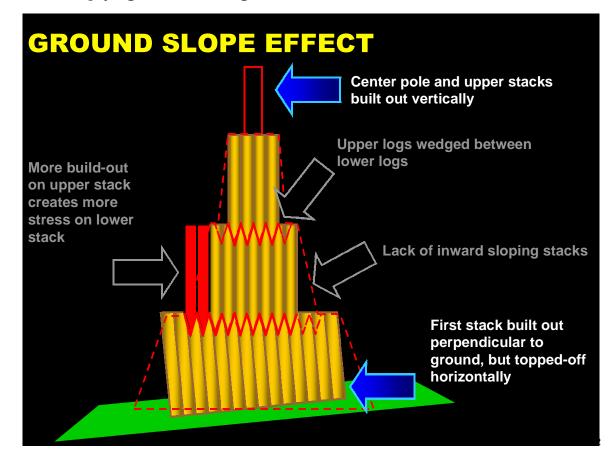
4. **Ground slope** – increases hoop stress on the downhill side of Bonfire. Two problems in this regard are worth noting. First, the ground at the polo field where Bonfire has been built since 1992 slopes very slightly from the northwest to the southeast. The engineers estimated this slope at just over 1 degree. This implies about a one-foot drop off from the northwest to the southeast side of the stack. This is a very slight drop, but it did contribute to increased hoop stress on the southeast side, which was the direction of failure. The second problem is that, according to interview reports, the first stack was built perpendicular to the ground, implying a very slight lean to the southeast. However, the second and higher stacks were built perpendicular to the forces of gravity and parallel to the center pole. Pre-collapse photo quality is such that the teams could not firmly corroborate reports of this condition. But it appears likely that it was present and contributed slightly to the collapse due to a leaning and prying effect of the logs.

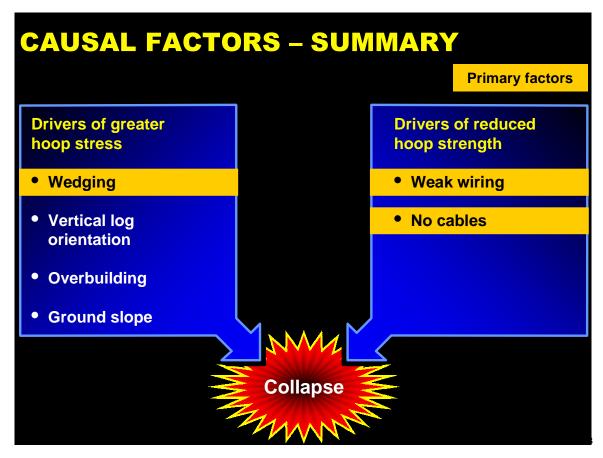
In summary, wedging, vertical log orientation, overbuilding, and ground slope combined to increase hoop stress, while weak wiring and lack of wrap-around cables combined to reduce hoop strength. The combination of these caused the Bonfire collapse.
